American Dream Home Inspection

SUMMARY REPORT

Inspection Address: 1783 N. Running Springs Street, Anaheim, CA 92807
Inspection Date: 9/17/2013 Start: 6:10 pm End: 7:18 pm

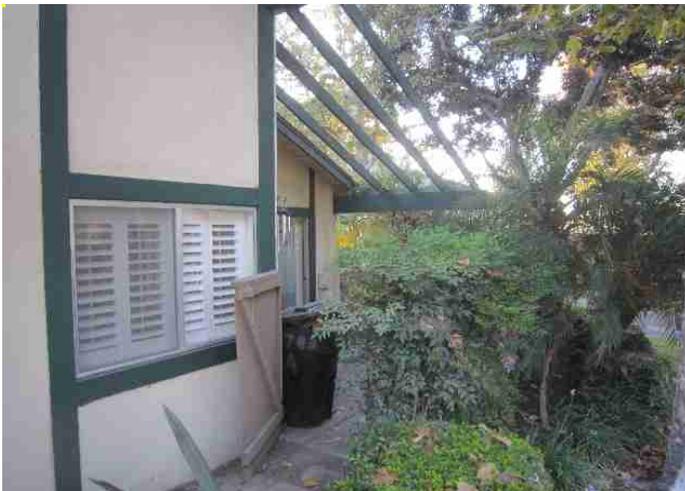
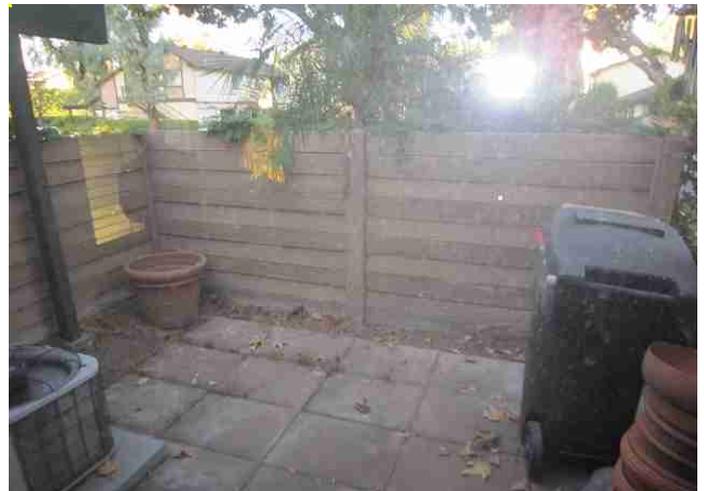
It is important to maintain a property, including painting or sealing walkways, decks, and other hard surfaces, and it is particularly important to keep the house walls sealed, which provide the only barrier against deterioration. Unsealed cracks around windows, doors, and thresholds can permit moisture intrusion, which is the principle cause of the deterioration of any surface. Unfortunately, the evidence of such intrusion may only be obvious when it is raining. We have discovered leaking windows while it was raining that may not have been apparent otherwise. Regardless, there are many styles of windows but only two basic types, single and dual-glazed. Dual-glazed windows are superior, because they provide a thermal as well as an acoustical barrier. However, the hermetic seals on these windows can fail at any time, and cause condensation to form between the panes. Unfortunately, this is not always apparent, which is why we disclaim an evaluation of hermetic seals. Nevertheless, in accordance with industry standards, we test a representative number of unobstructed windows, and ensure that at least one window in every bedroom is operable and facilitates an emergency exit.

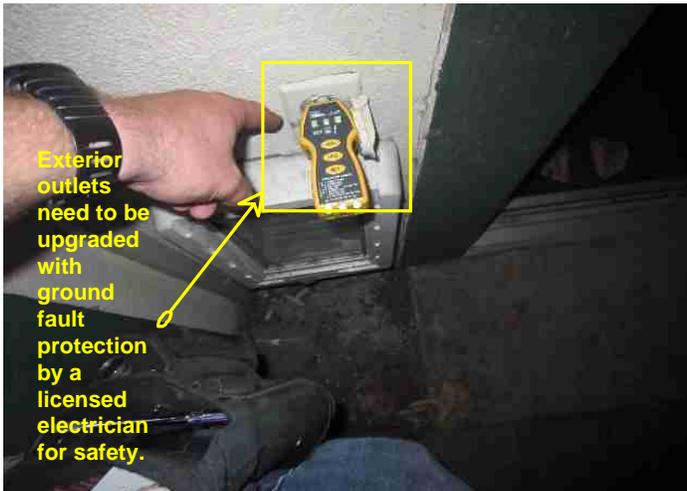
All of the exterior outlets should be upgraded to have ground-fault protection by a licensed electrician - *Continued*

All of the exterior outlets should be upgraded to have ground fault protection by a licensed electrician before close of escrow for safety.

- All of the exterior outlets should be upgraded to have ground-fault protection by a licensed electrician

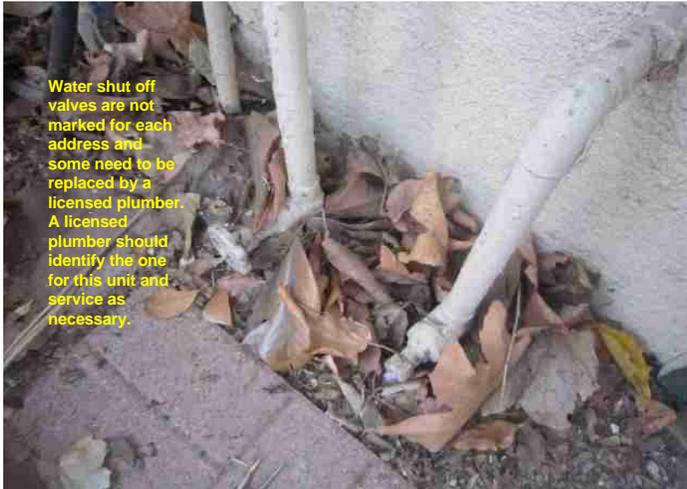
The main water shut-off valves are not labeled or marked with addresses and should be identified - *Continued*

Water shut off valves are not marked for each address and some need to be replaced by a licensed plumber. A licensed plumber should identify the one for this unit and service as necessary before close of escrow. A ball type lever valve should be installed.

- The main water shut-off valves are not labeled or marked with addresses and should be identified

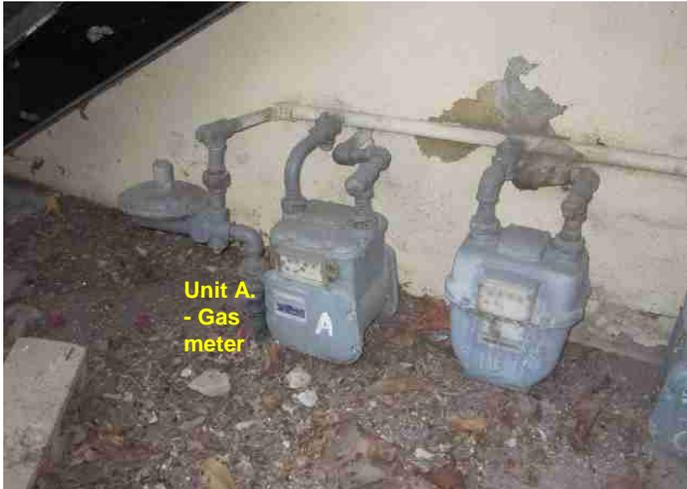
The gas main shut-off is located in the side yard - *Continued*

The gas main shut-off is located in the side yard. You should be aware that gas leaks are not uncommon, particularly underground ones, and that they can be difficult to detect without the use of sophisticated instruments, which is why natural gas is odorized in the manufacturing process. Therefore, we recommend that you request a recent gas bill from the sellers, so that you can establish a norm and thereby be alerted to any potential leak.

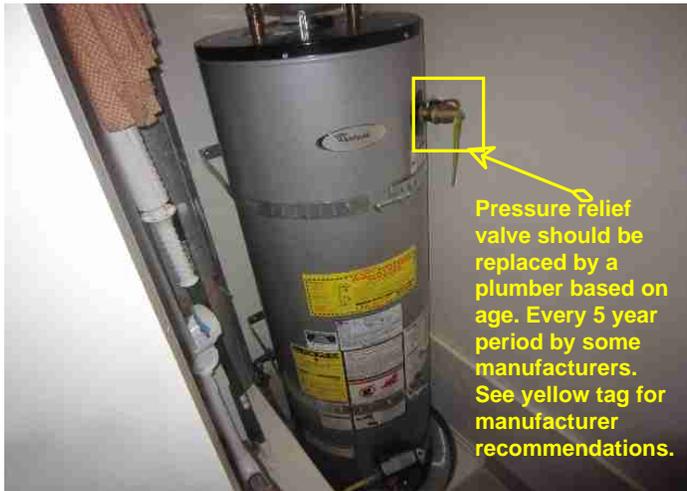
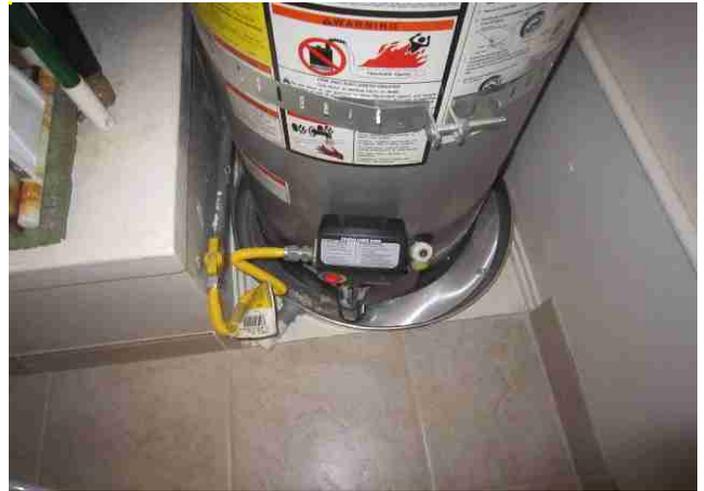
The water heater temperature and pressure relief valve should be replaced by a plumber based on the age of unit - Conti

The water heater temperature and pressure relief valve should be replaced based by a licensed plumber based on age of the water heater. Most manufacturers require valves be tested annually, and if not they should be replaced for safety reasons. A licensed plumber should replace the valve if it has not been tested annually.

- The water heater temperature and pressure relief valve should be replaced by a plumber based on the age of unit

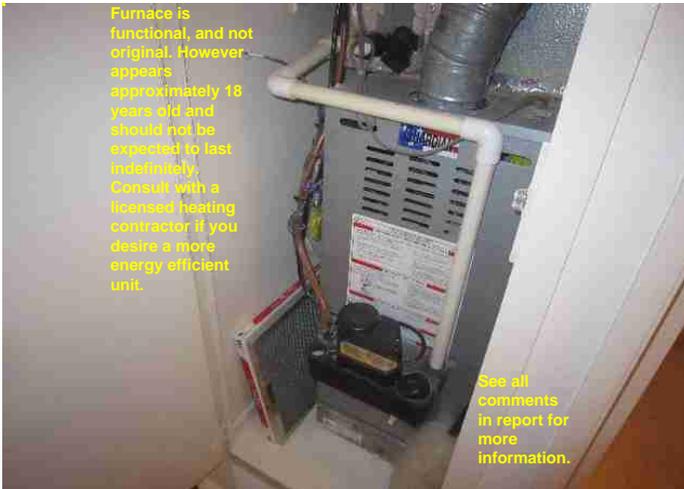
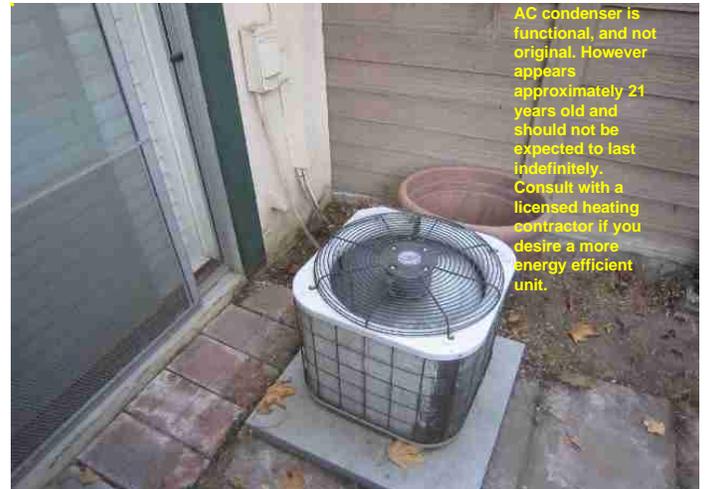
Central heat and air-conditioning are provided by a single split-system, consisting of an approximately 18 year-old Guardian make furnace with an evaporator coil that is located in laundry room , and an approximately 21 year-old, Carrier make AC condensing coil that is located in rear yard.

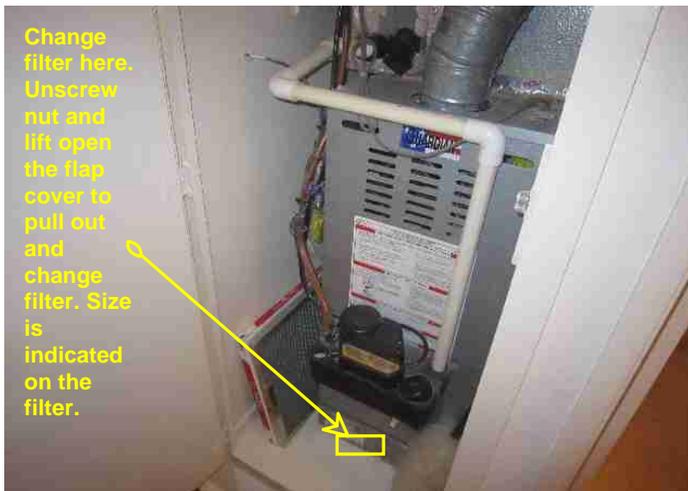
The filter is dirty and should be changed now and at a minimum every three months thereafter. If filters are not changed regularly, the evaporator coil and the ducts can become contaminated, and can be expensive to clean.

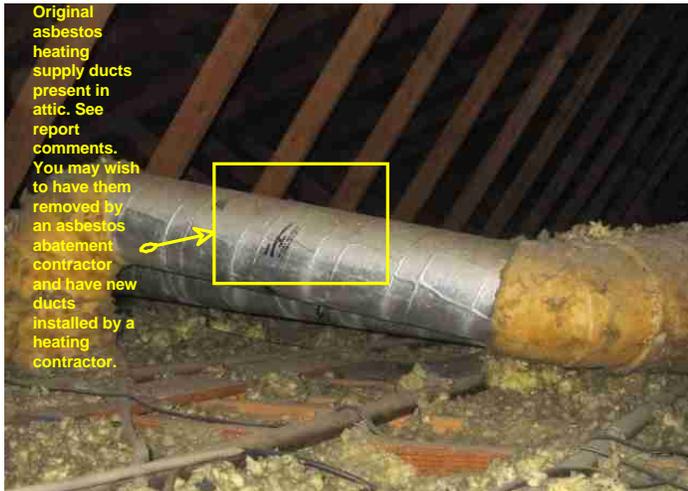
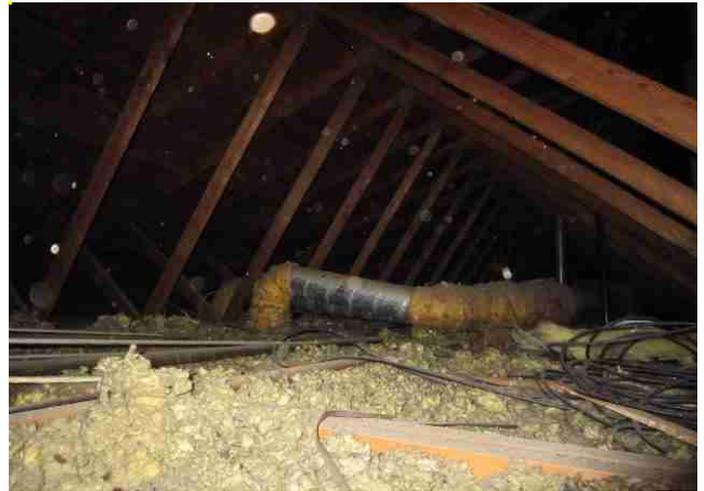
The ducts are old obsolete and insulated with a asbestos-containing material and replacement recommended - *Continued*

- The ducts are old obsolete and insulated with a asbestos-containing material and replacement recommended

Consult with a licensed heating contractor if you desire new heating/cooling supply ducts installed.

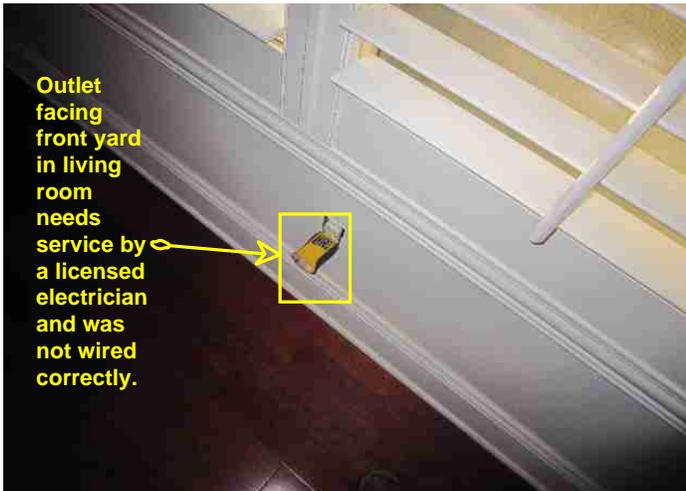
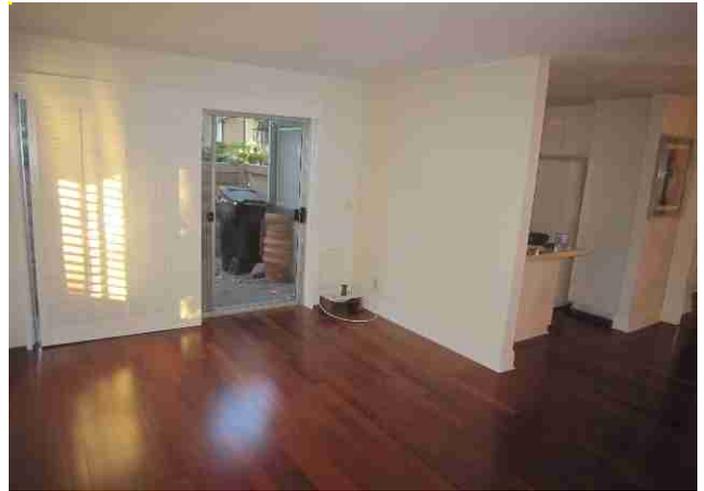
An outlet has a hot-ground reverse and should be serviced by a licensed electrician for safety - *Continued*

An outlet has a hot-ground reverse and should be serviced by a licensed electrician for safety before close of escrow. This outlet is facing the front yard area on main entry door side.

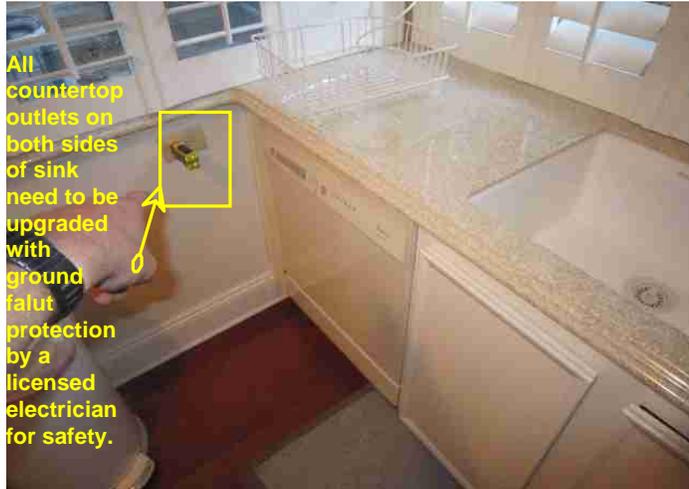
All of the countertop outlets should be upgraded to have ground fault protection by a licensed electrician for safety before close of escrow, which is mandated by current standards and is an important safety feature.

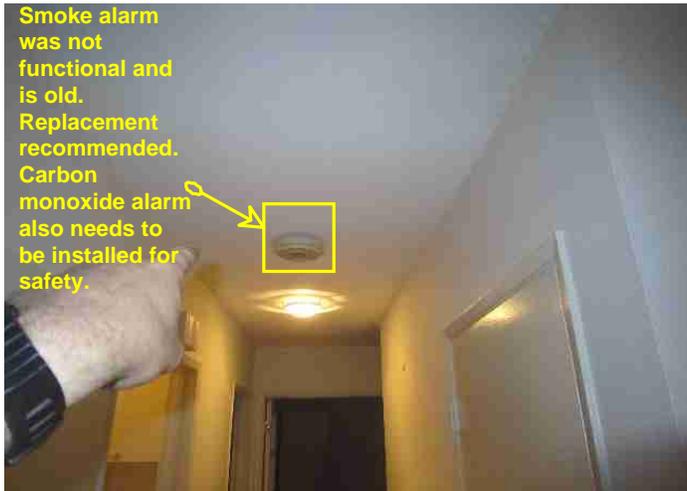
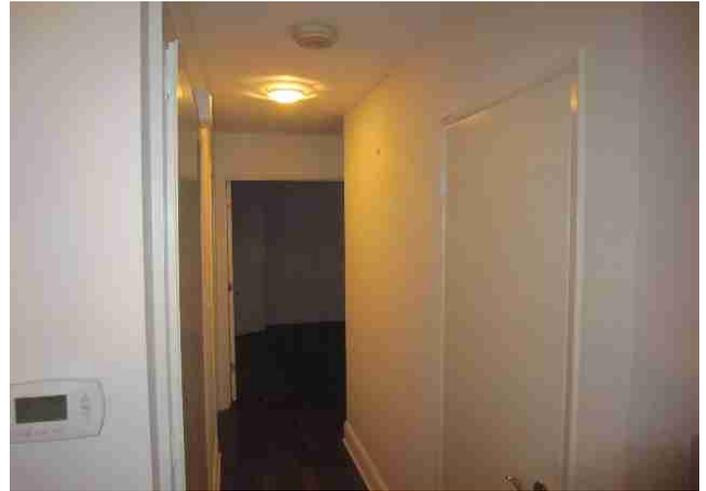
The smoke detector did not respond and should be replaced based on age for fire safety - *Continued*

The smoke detector did not respond and should be replaced based on age for fire safety. Smoke alarms are mandated in all hallways and bedrooms and should be installed before close of escrow and tested periodically.

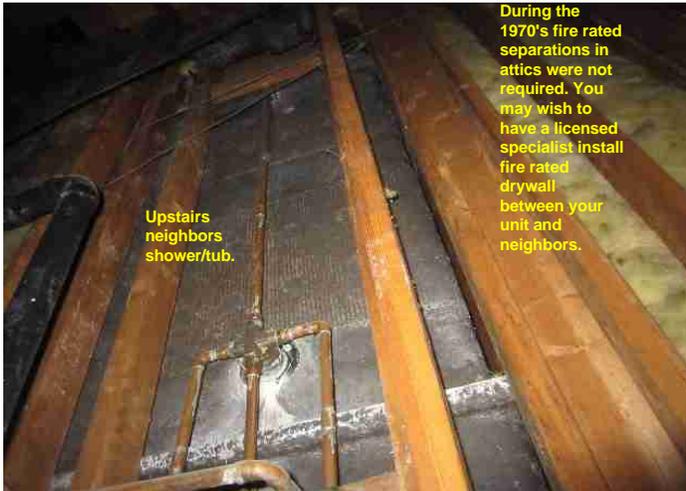
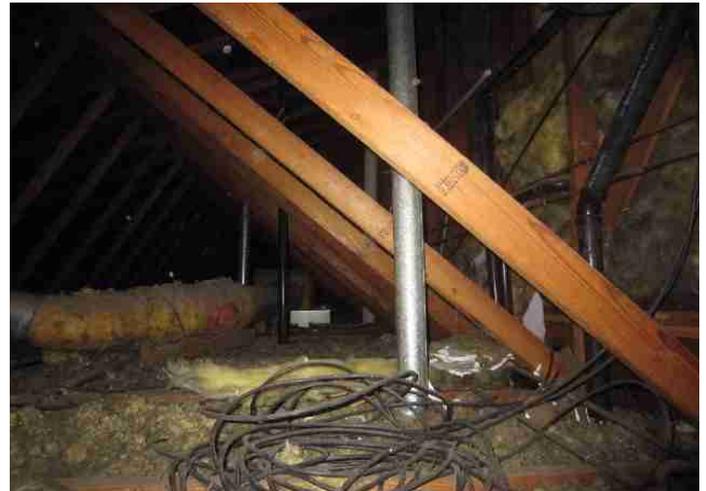
There is no fire-resistive wall between the units, which is required to inhibit the spread of a fire, and represents a safety-hazard that should be corrected as soon as conveniently possible. Consult with a licensed specialist or drywall specialist to install Type X or fire rated drywall between the units in attic. During the 1970's fire rated separations in attics were not required. You may wish to have a licensed specialist install fire rated drywall between your unit and neighbors.

You may wish to also consult with the Association regarding this issue between neighbors. The Association may not be aware of this safety issue and may wish to address concerns within the community.

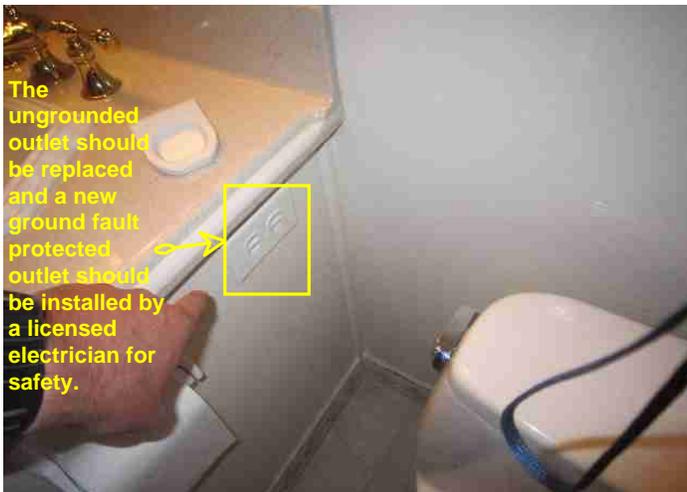
The ungrounded outlet near toilet and in cabinet should be upgraded to have ground-fault protection by a licensed electrician before close of escrow for safety.

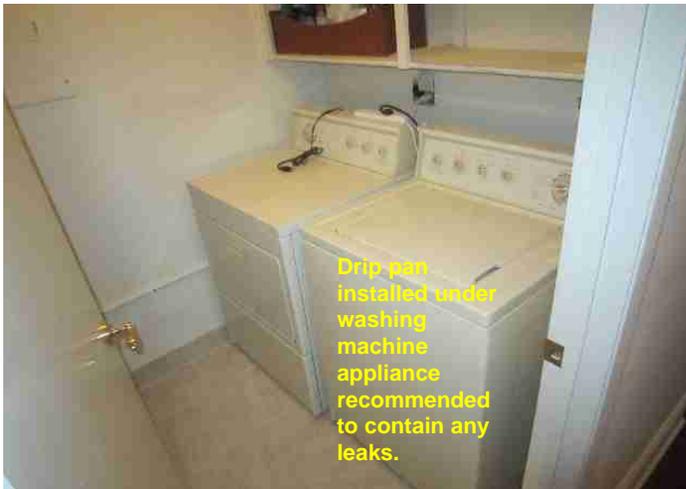
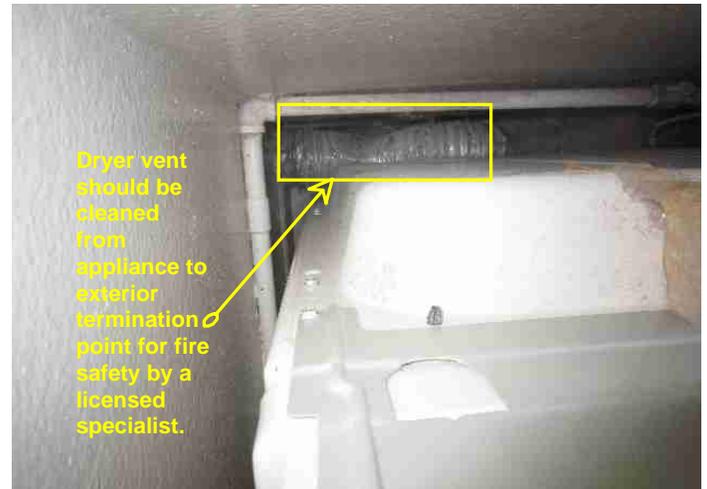
Faulty dryer vents have been responsible for thousands of fires, hundreds of injuries, and even deaths. The best vents are a smooth-walled metal type that travels a short distance; all other types should be regarded as suspect, and should be inspected bi-annually to ensure that they do not contain trapped lint or moisture. The dryer vent should be cleaned to its termination point by a licensed specialist for fire safety reasons before close of escrow, and annually thereafter. Dryer vents can become obstructed with lint and can become fire hazards.
